## **Island Manager Report November 14, 2020**

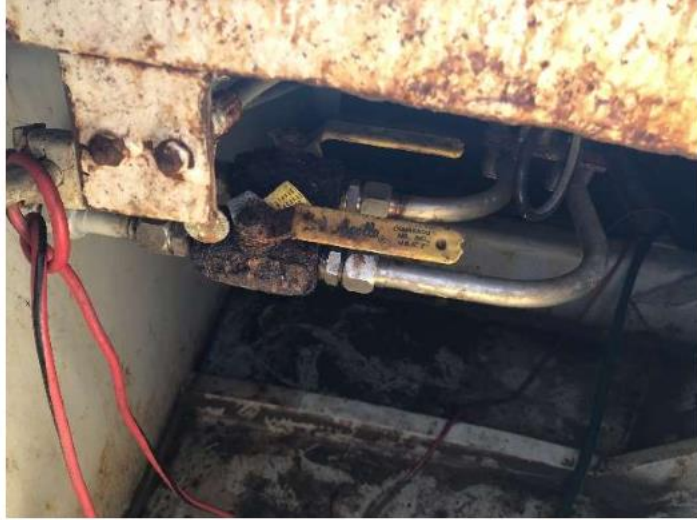
*Figure 1: Corroded hydraulic steering cutoff valve, improper wiring configuration, and rusted bottom plate.*

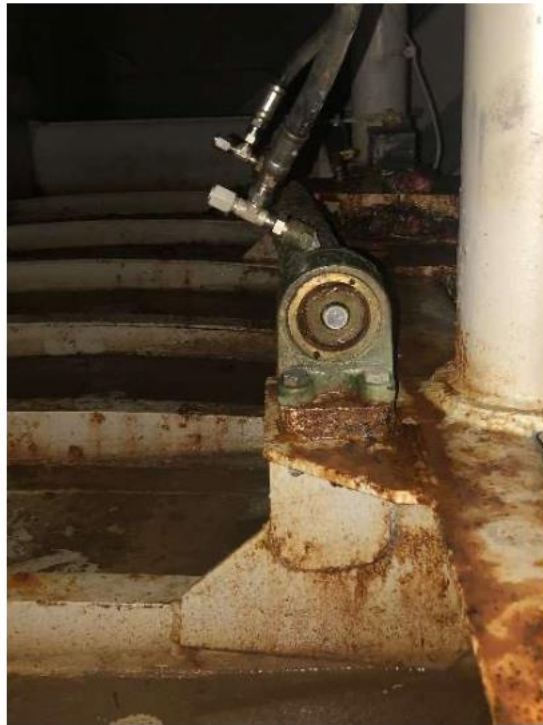
*Figure 2: Corroded steering gear ram foundation and rusted bottom plated.*

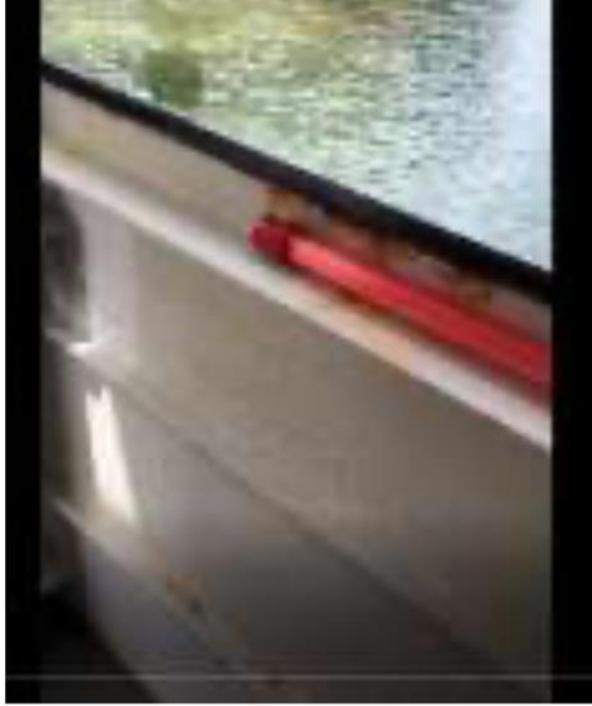
*Figure 20: Insufficient sealing causing stbd side shell to rust from improper window sealing.*
