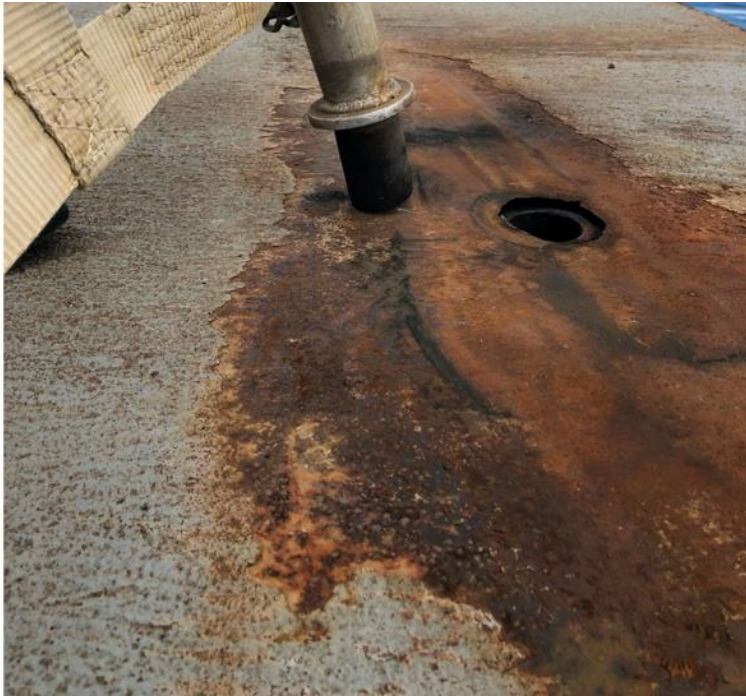
*Figure 19: Stanchion system showing substantial corrosion, rust, and paint chipping.*
