Island Manager Report October 10, 2020

Shipyard

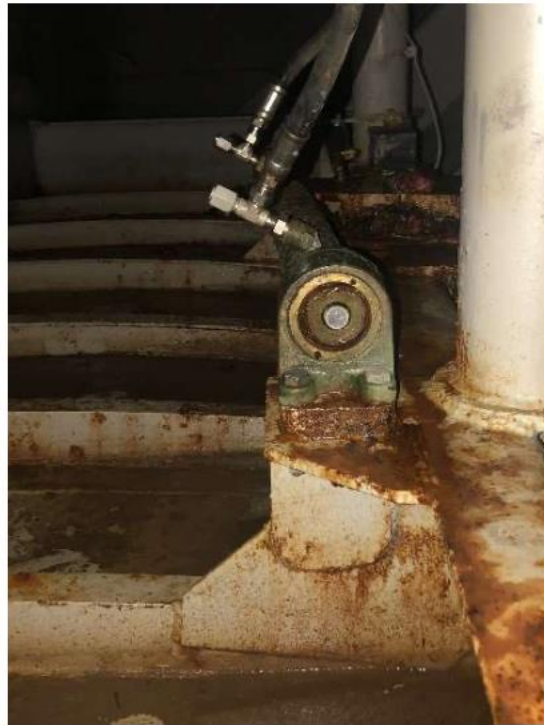
Figure 2: Corroded steering gear ram foundation and rusted bottom plated.

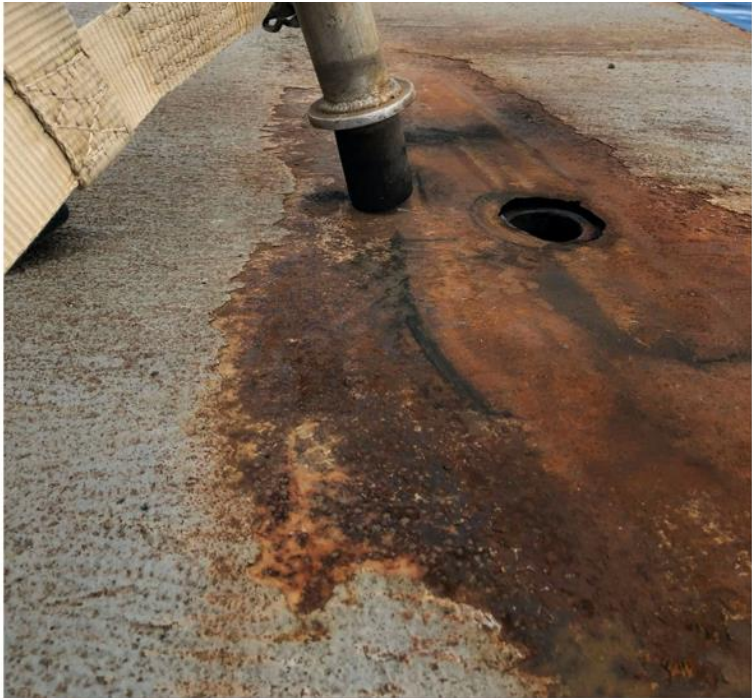
Figure 19: Stanchion system showing substantial corrosion, rust, and paint chipping.
